# Sinkhole Analysis and Classification Using Pictometry in Genesee County, NY and Surrounding Areas

A Thesis

Presented to the Faculty of the Department of Environmental Science and Biology  
of the State University of New York College at Brockport

December 2015

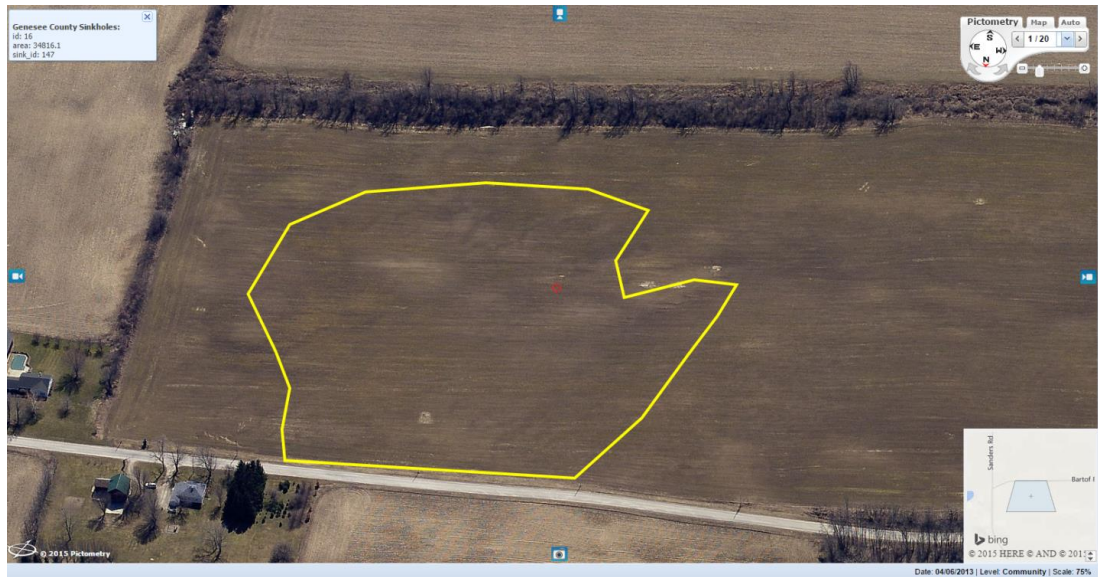
Figure 9b. Sinkhole #16 in the early spring before vegetation growth. Obvious are large clusters of sub-angular boulders, indicating shallow depth-to-bedrock. Note the soil discoloration due to enhanced moisture in micro-relief regions. View from north.

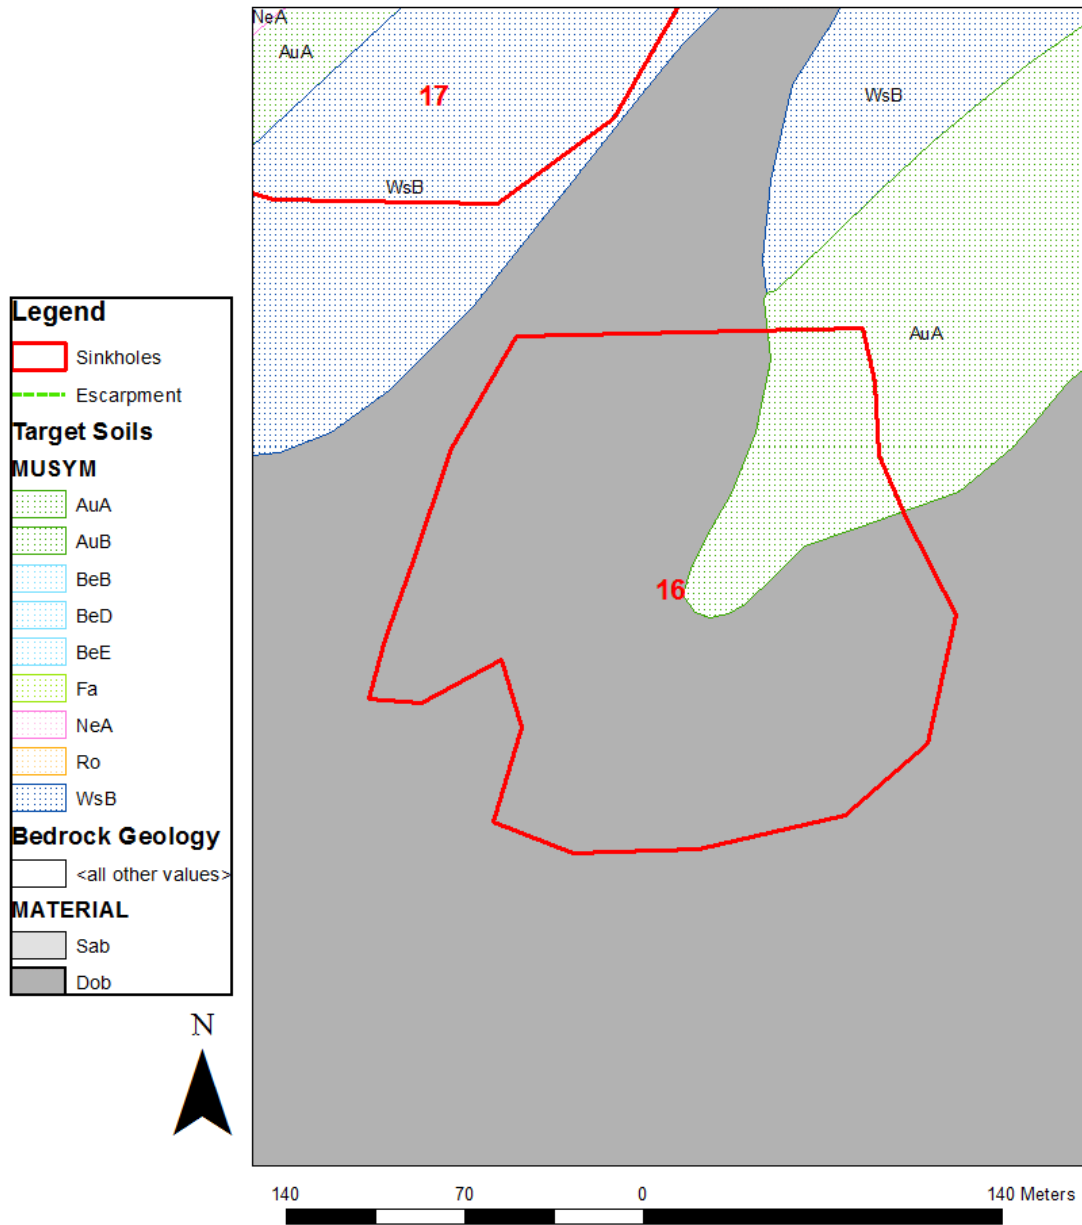
## Sinkhole #16

Figure 9c. GIS-based map product for Sinkhole #16. This feature is mostly smooth, moderately sized and lies within the Onondaga Formation. This sinkhole has interaction with the target soil, specifically, the Aurora series.

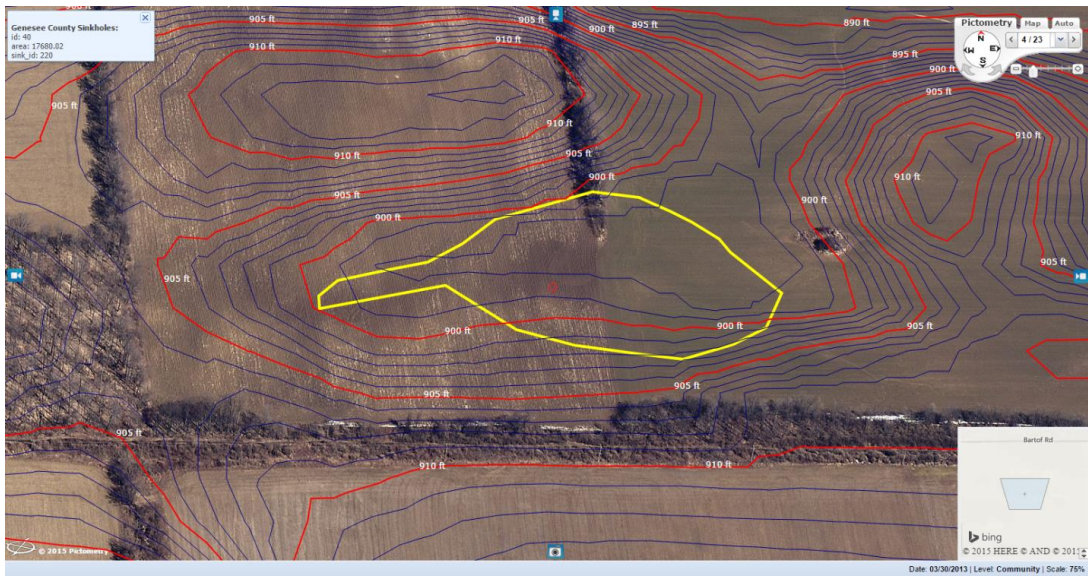
Figure 10a. Sinkhole #40 in Stafford, NY. This feature lies fairly squarely in the center of a depression as indicated by contours. At the center of this feature is a darkened soil region, likely due to enhanced moisture. To the east of the feature is a rock spoil pile, indicative of stony fields and potentially shallow depth-to-bedrock.

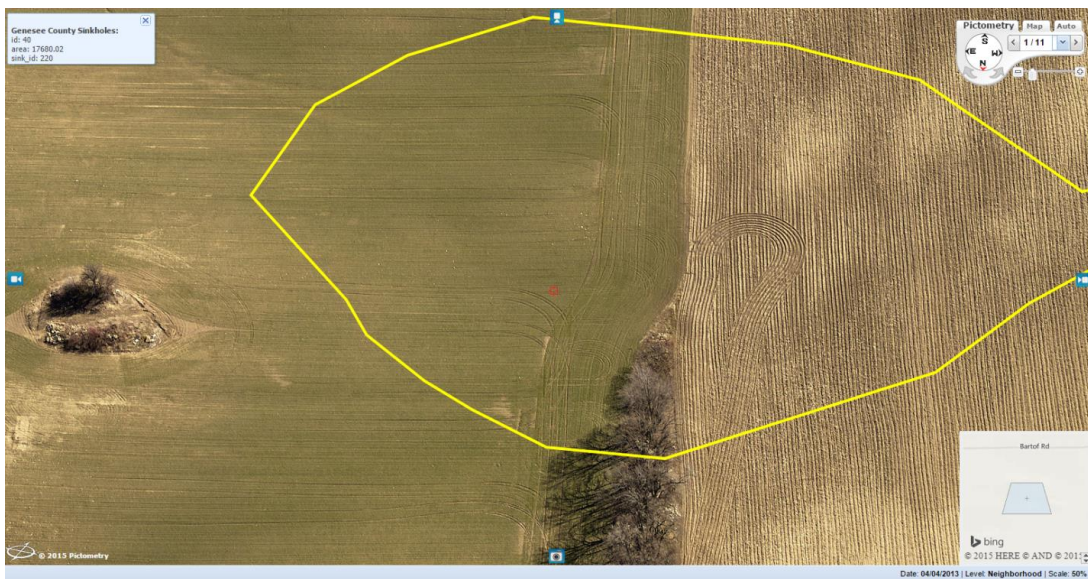
Figure 10b. Close-up of Sinkhole #40, with a spoil pile to the east of the feature (left of image). Scattered throughout both fields associated are sub-angular boulders. View from north.

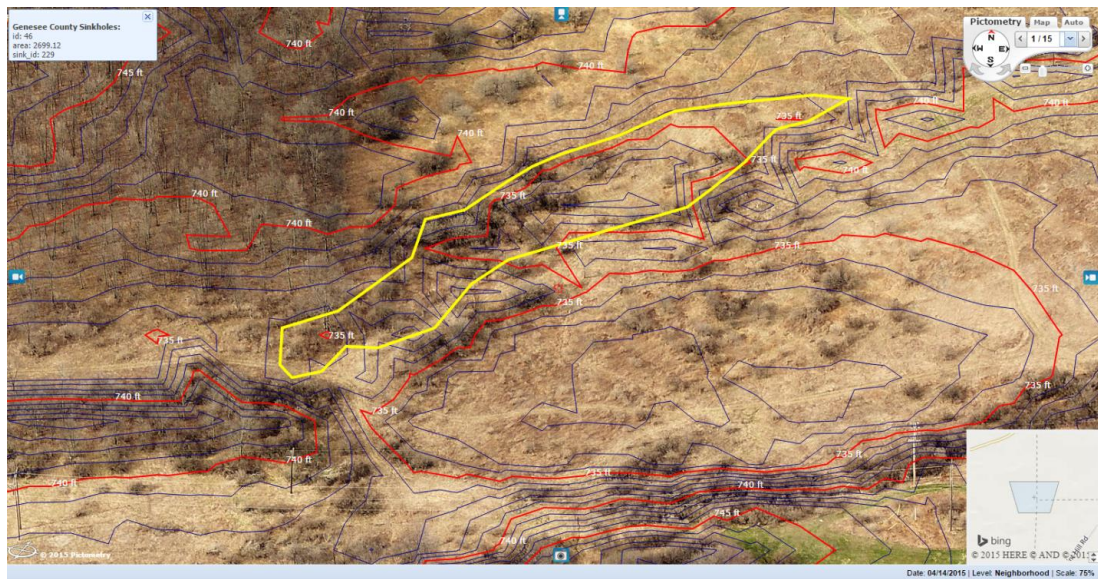
Figure 11a. Sinkhole #46 is a dry, land-based feature in LeRoy, NY. It is dominated by shrubs and soil. This feature encompasses two low points in topography, as noted by contours.

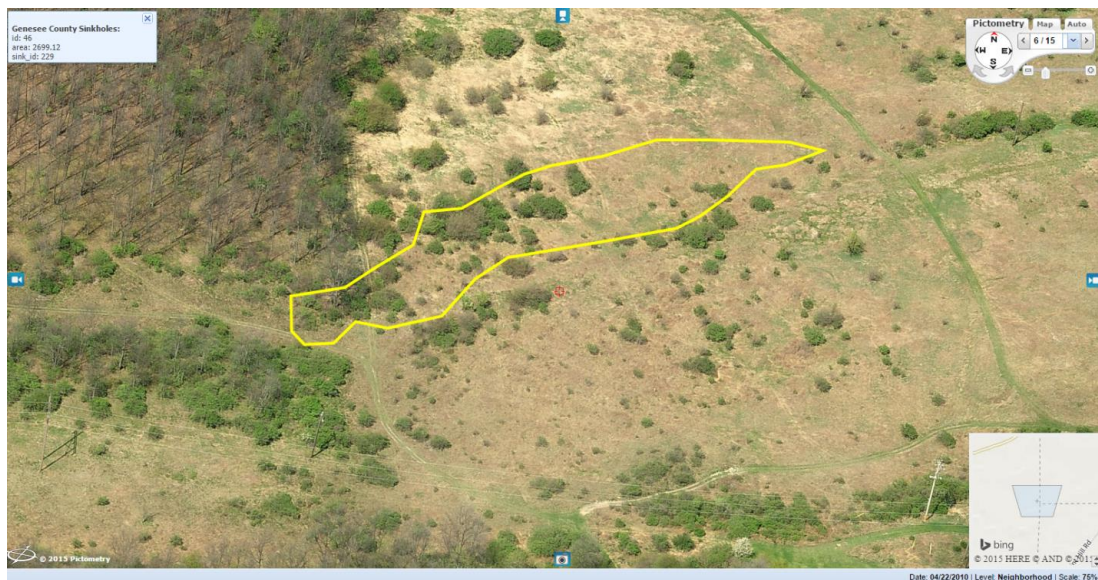
Figure 11b. Sinkhole #46 with spring growth evident. This feature is still absent any noticeable moisture on the surface, and apart from the shrubs, little else appears to grow within the feature.

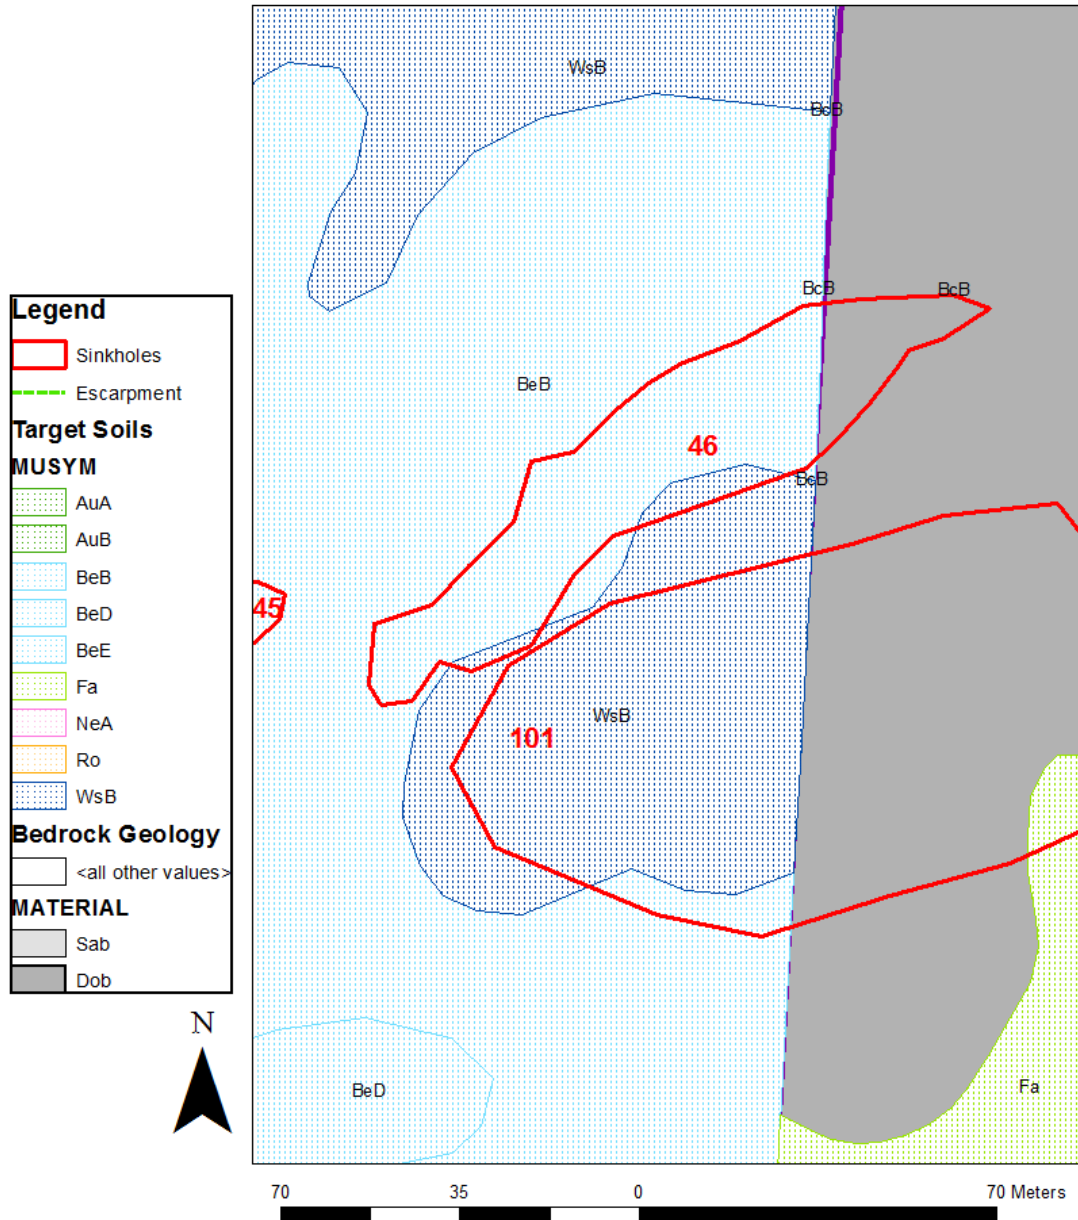
## Sinkhole #46

Figure 11c. GIS-based map product for Sinkhole #46. This sinkhole lies within the Onondaga Formation and is completely filled with target soils – specifically from the Benson and Wassiac groups. A key feature of note is the close proximity of another sinkhole – sinkhole #101 – just to the south and east of #46.

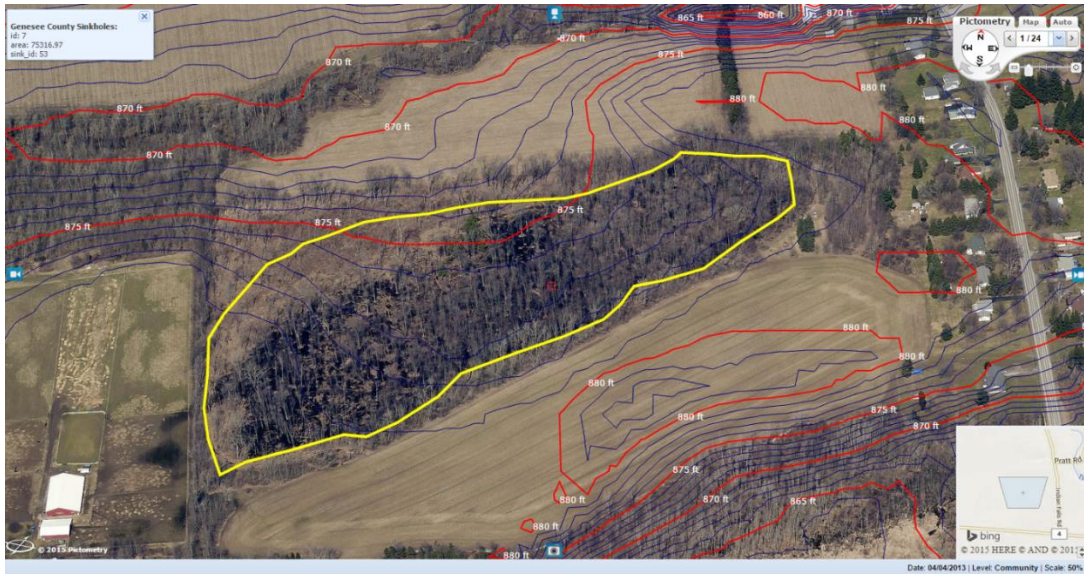
Figure 12a. This time-step shows Sinkhole #7 during a wet stage, likely from a snowmelt event. It is surrounded on three sides by farm fields, meaning this feature is likely inundated with farm-based pollution runoff.

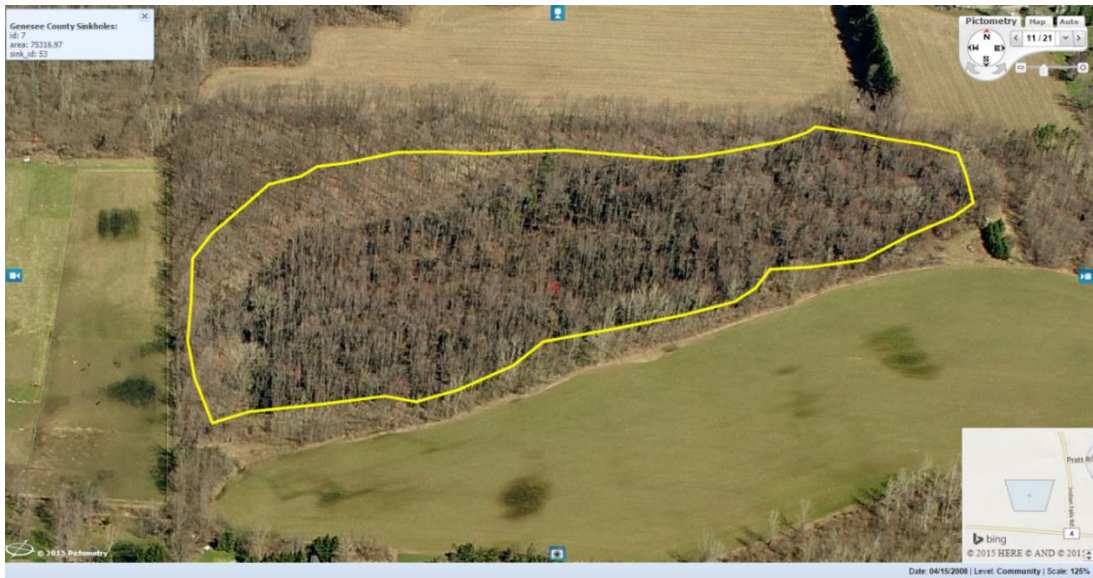
Figure 12b. A drier time-step for Sinkhole #7; while most moisture has left the sinkhole itself, soil discoloration, likely due to moisture, is observed in the surrounding fields.

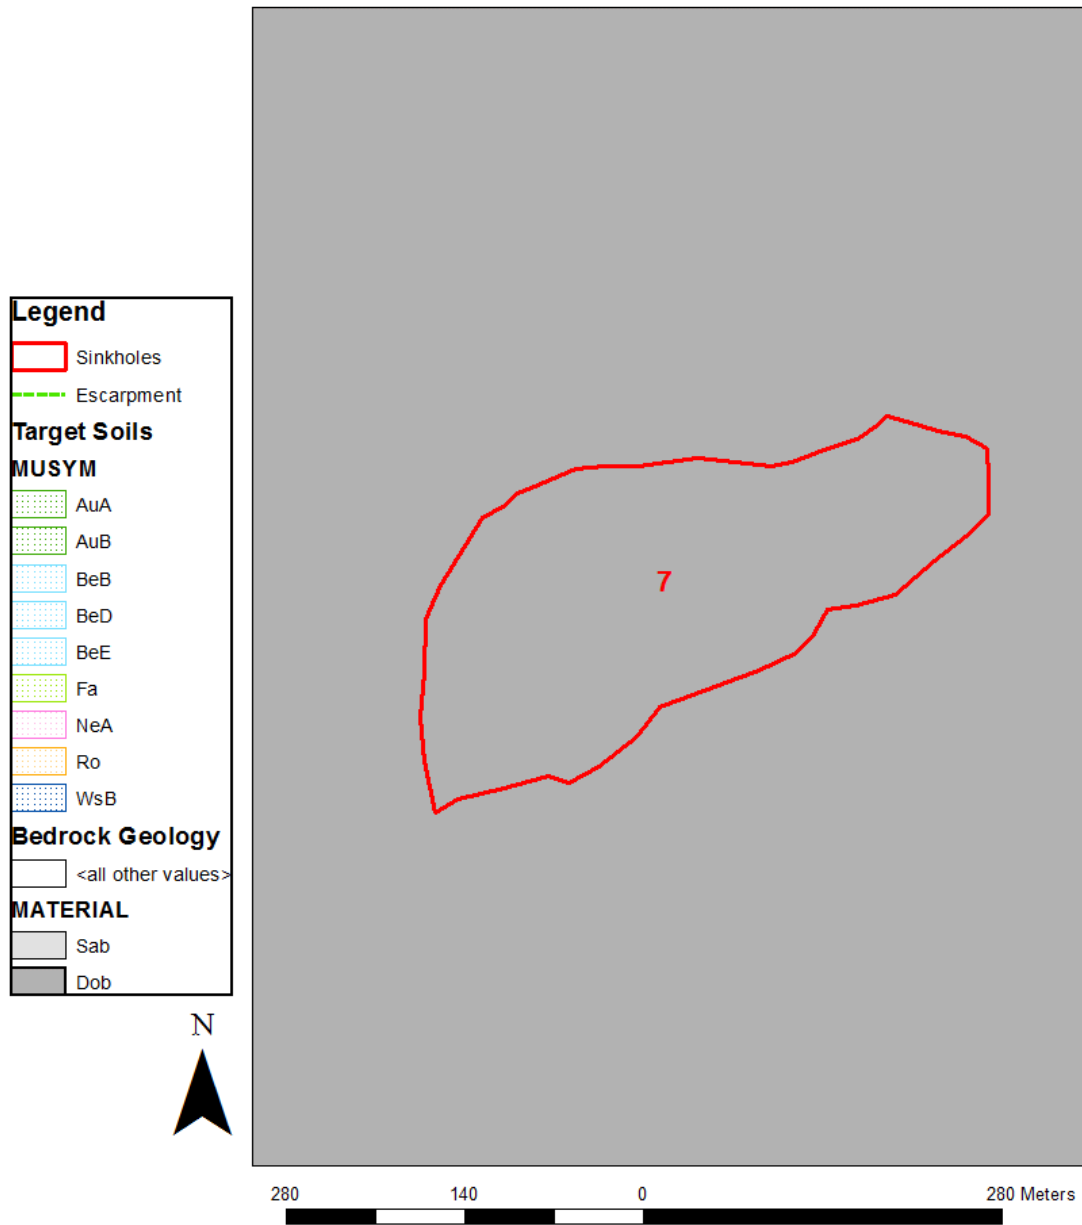
## Sinkhole #7

Figure 12c. GIS-Based map product for Sinkhole #7. This shows that the sinkhole lies fully within the Onondaga Formation and has no nearby target soils associated with it.

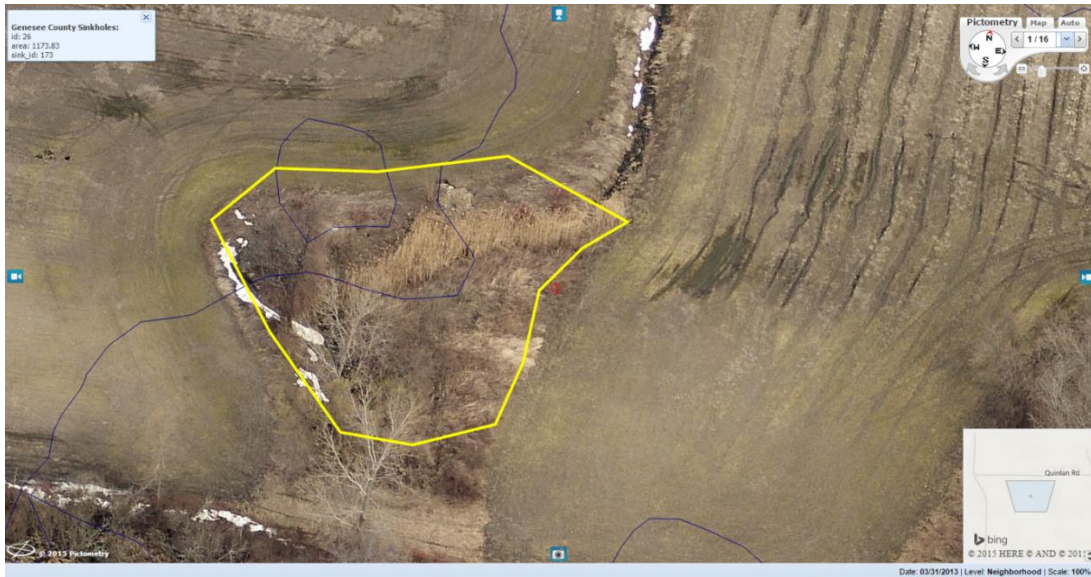
Figure 13a. Sinkhole # 26 is located along a stream section, at the low-point between to farm fields. The surrounding area appears quite moist, while inside the feature is very brush-filled and non-farmed, a sign of high moisture content extending away from the stream itself.

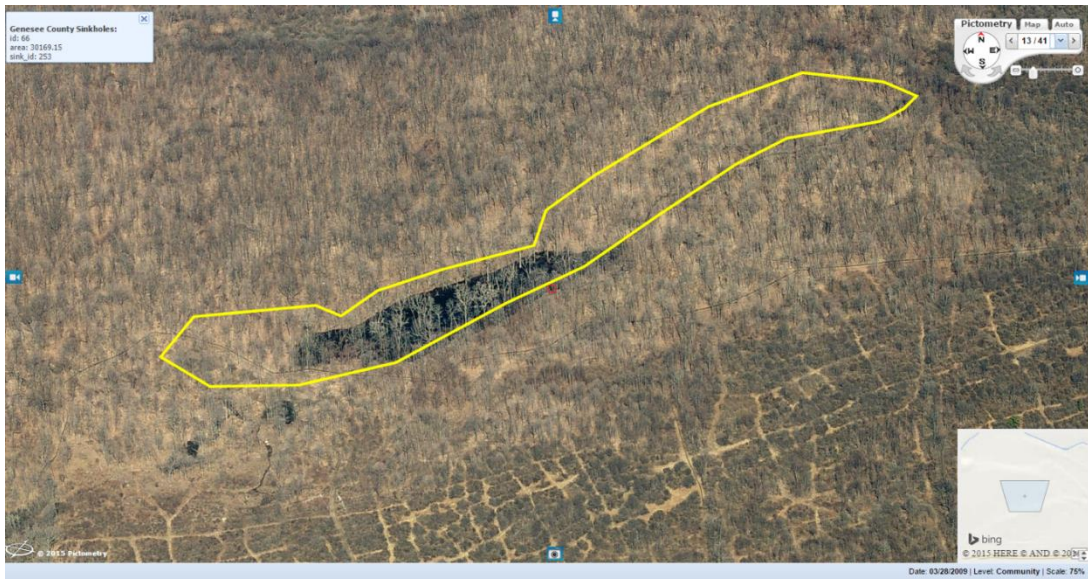
Figure 14a. A wet time-step for Sinkhole #66. This shows the feature after a snowmelt, creating a vernal pool.

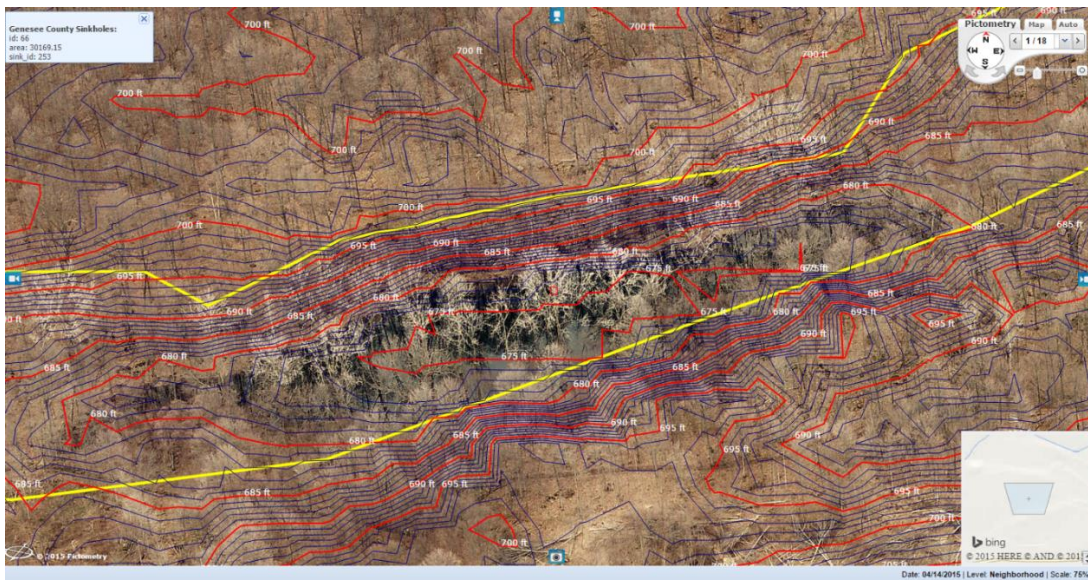
Figure 14b. Another wet time-step for Sinkhole #66. With contours enabled, it becomes apparent how steep the cliffs of this feature are, specifically on the northern and southern edges.

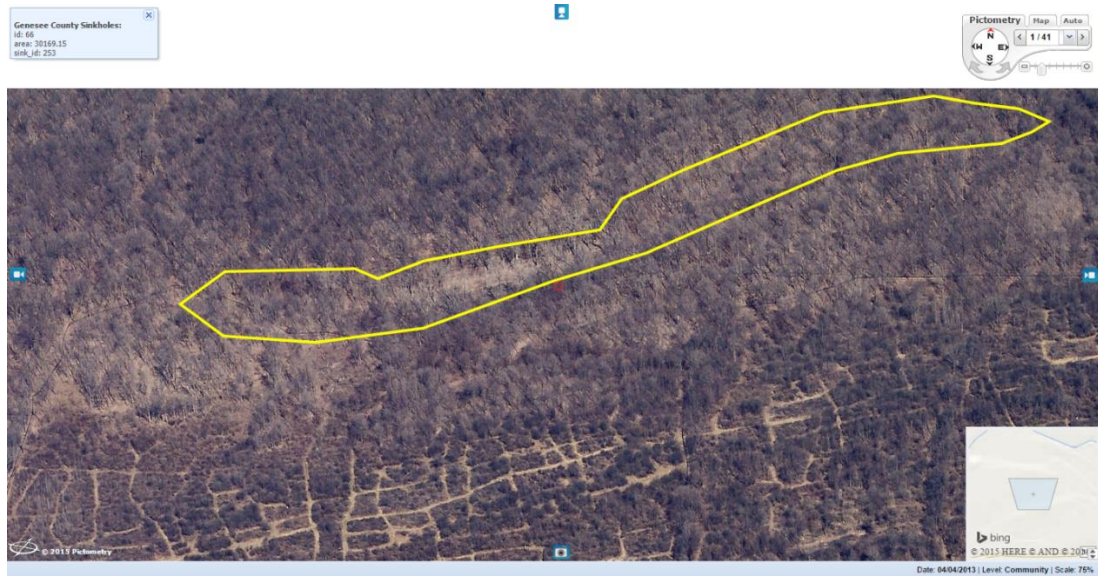
Figure 14c. Dry time-step for Sinkhole #66; this feature is completely absent of water in the visible imagery.

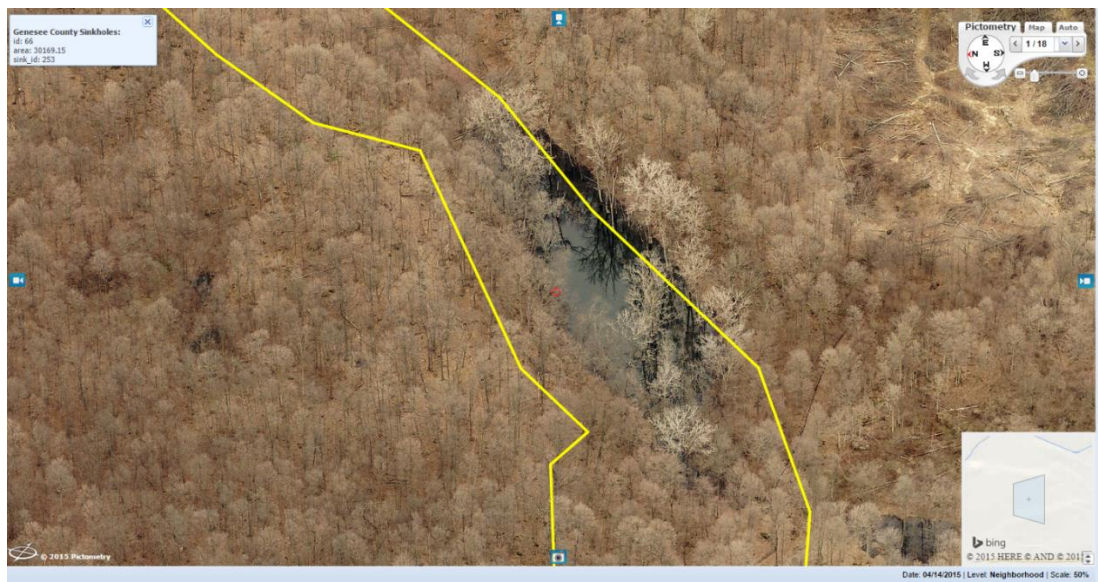
Figure 14d. Looking along the fetch of Sinkhole #66 (from the west) it shows obvious ponding with trees throughout the flooded region.

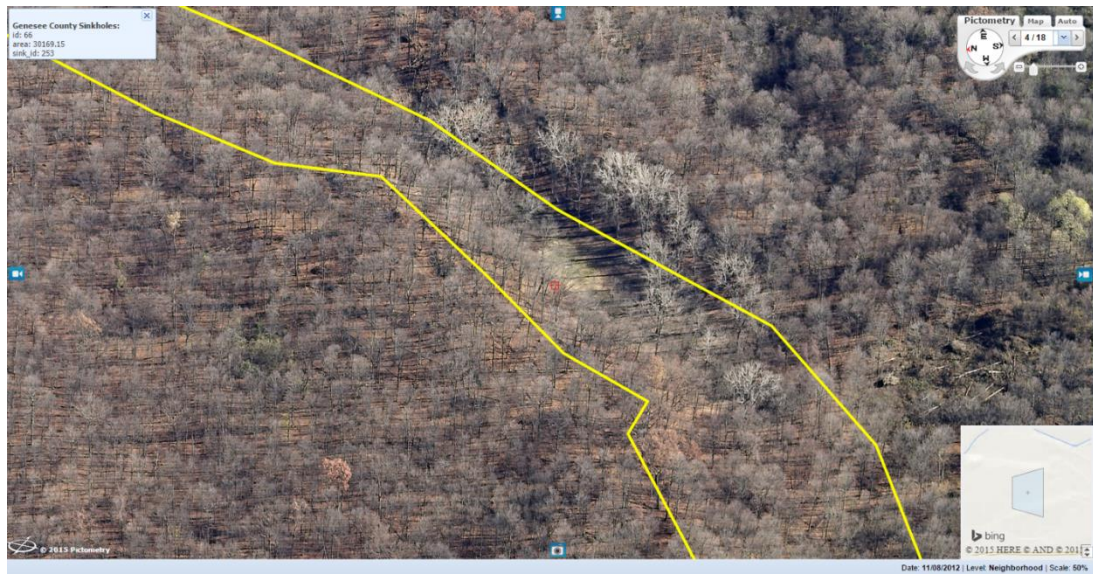
Figure 14e. Looking along the fetch of the pond in Sinkhole #66, during a dry time-step, the feature appear completely dry and barren.

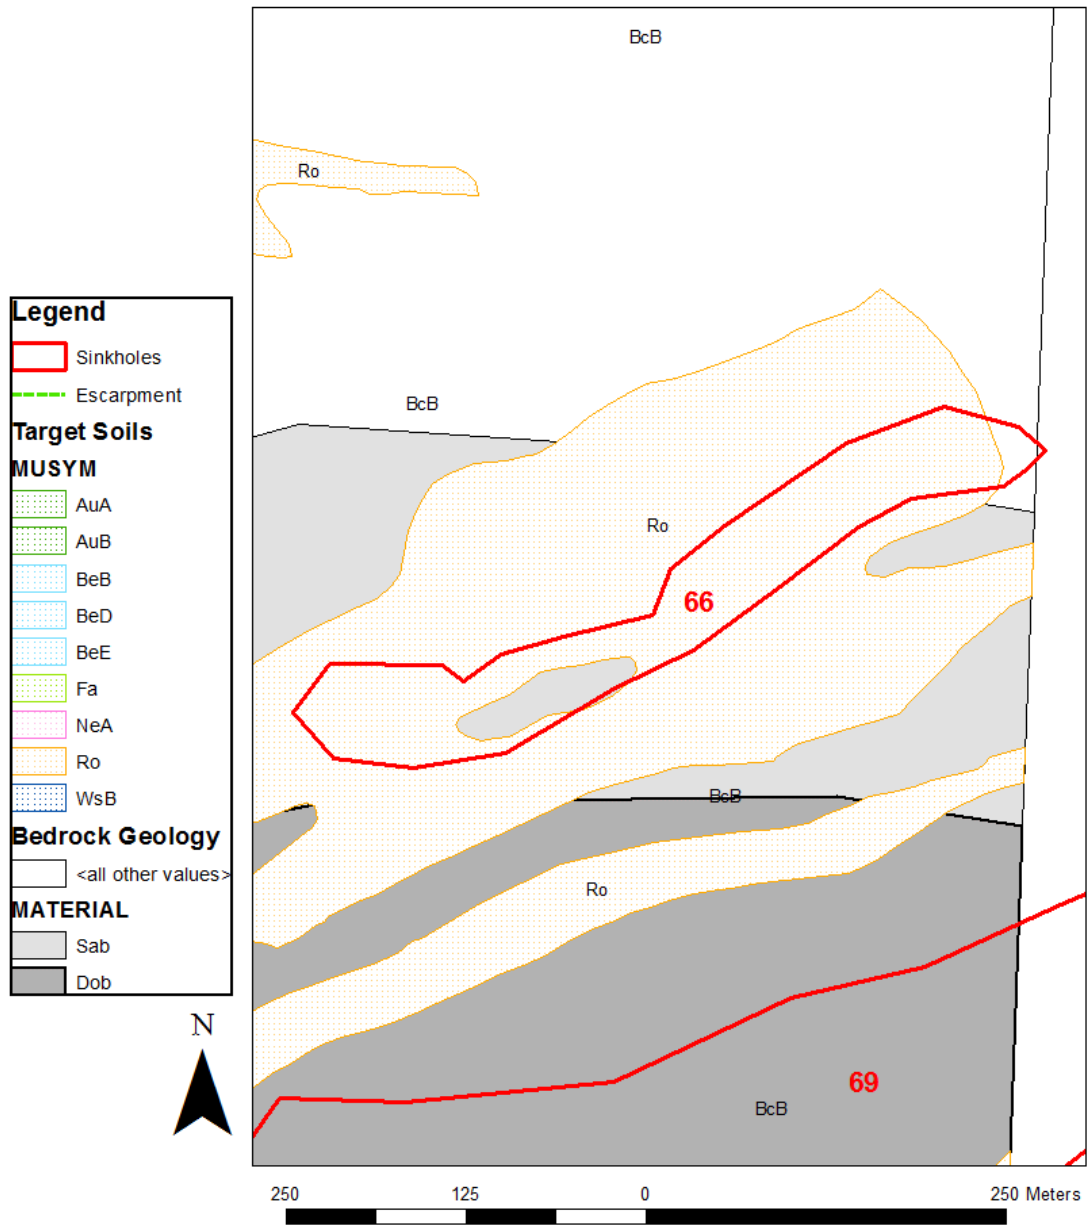
## Sinkhole #66

Figure 14f. GIS-based map product for Sinkhole #66, this feature lies mainly within the Akron-Bertie Formation, while extending slightly into the Camillus group. Target soils span nearly the entire feature, in the form of the Rubbleland series, while a small pocket is absent target soils in the center, due to the ponding that takes place.

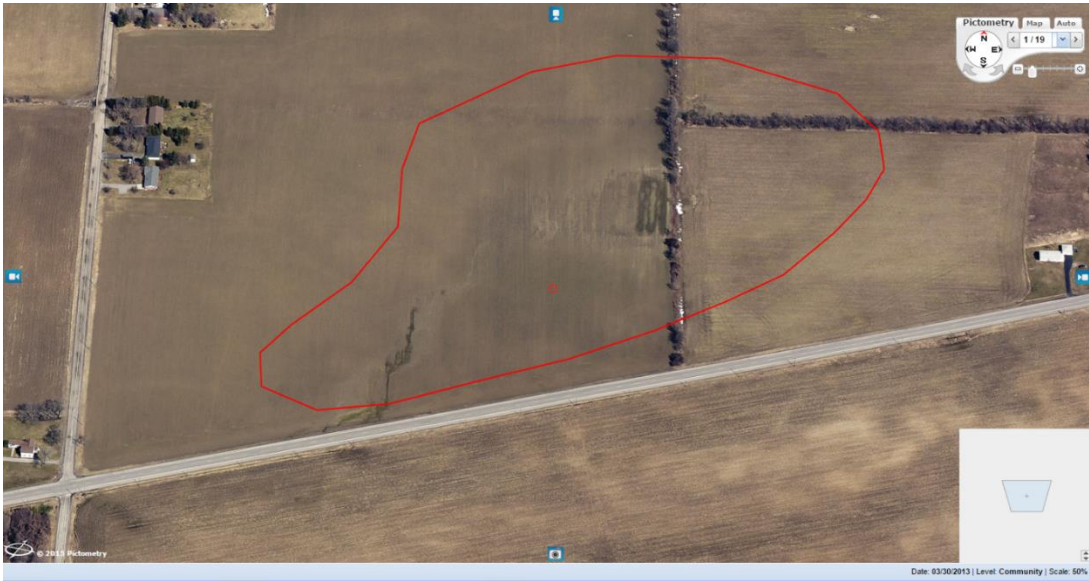
Figure 15a. Moist time-step of the disappearing lake at Ivison Rd. in Sinkhole # 25. Not only is there ponding at the very center, but visible ‘stream’ formation is seen in the southwest portion of the feature.

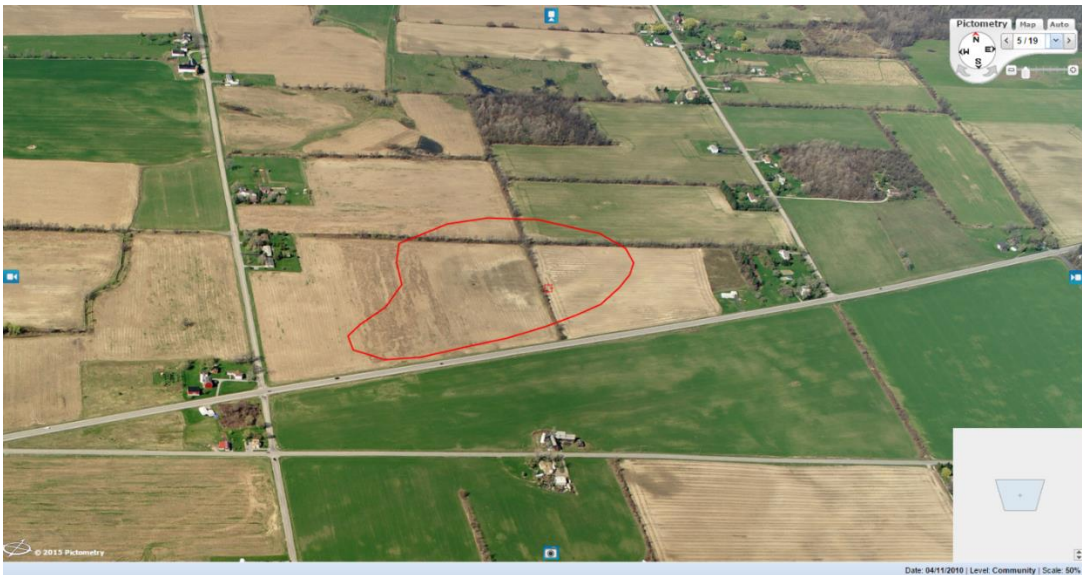
Figure 15b. Dry time-step of Sinkhole #25. Although absent of water, the Ivison Rd. disappearing lake still shows signs of soil discoloration, likely due to enhanced subsurface moisture.

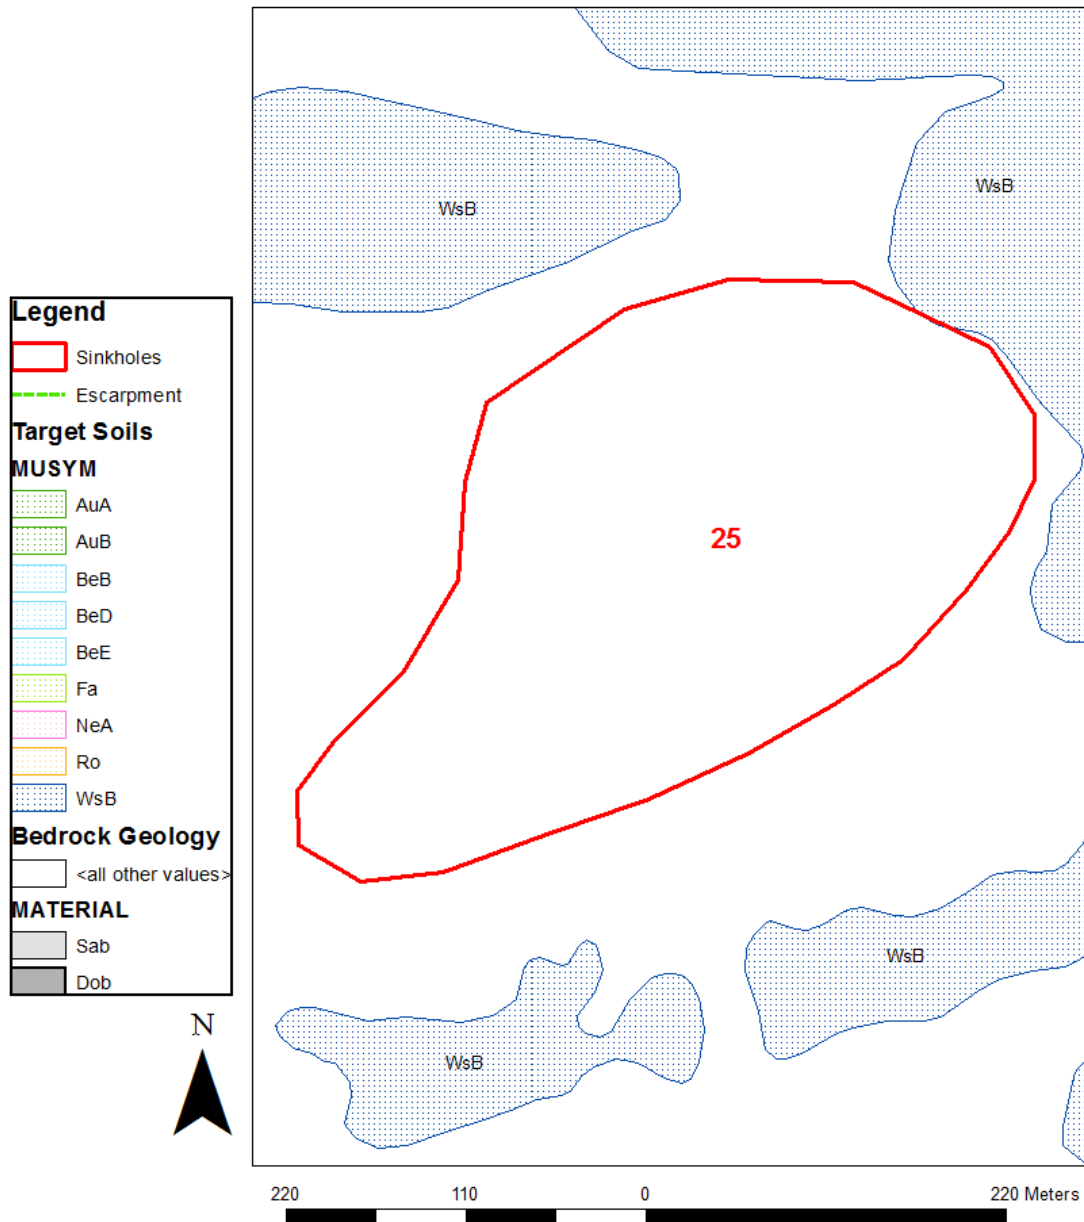
## Iverson Disappearing Lake

Figure 15c. GIS-based map product of the Iverson Rd. disappearing lake. This feature lies fully within the Camillus group and has no target soils within; however, it is surrounded on three sides by the Wassiac group target soil.

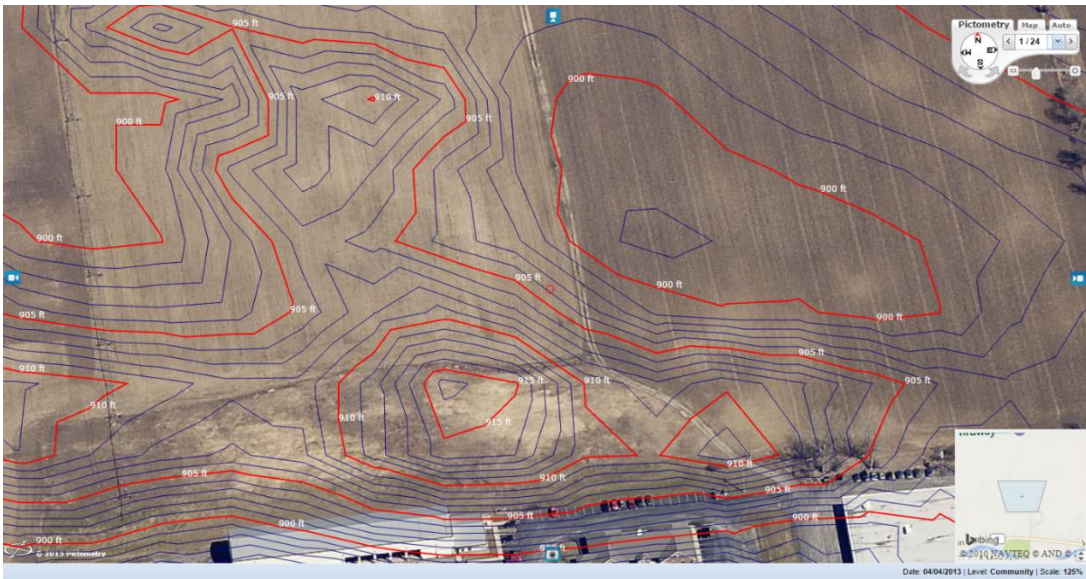
Figure 16b. Zoomed-out look at the false-positive site at County Building 2. Note the topographic low in the middle-right, which initially was mistaken as a sinkhole.

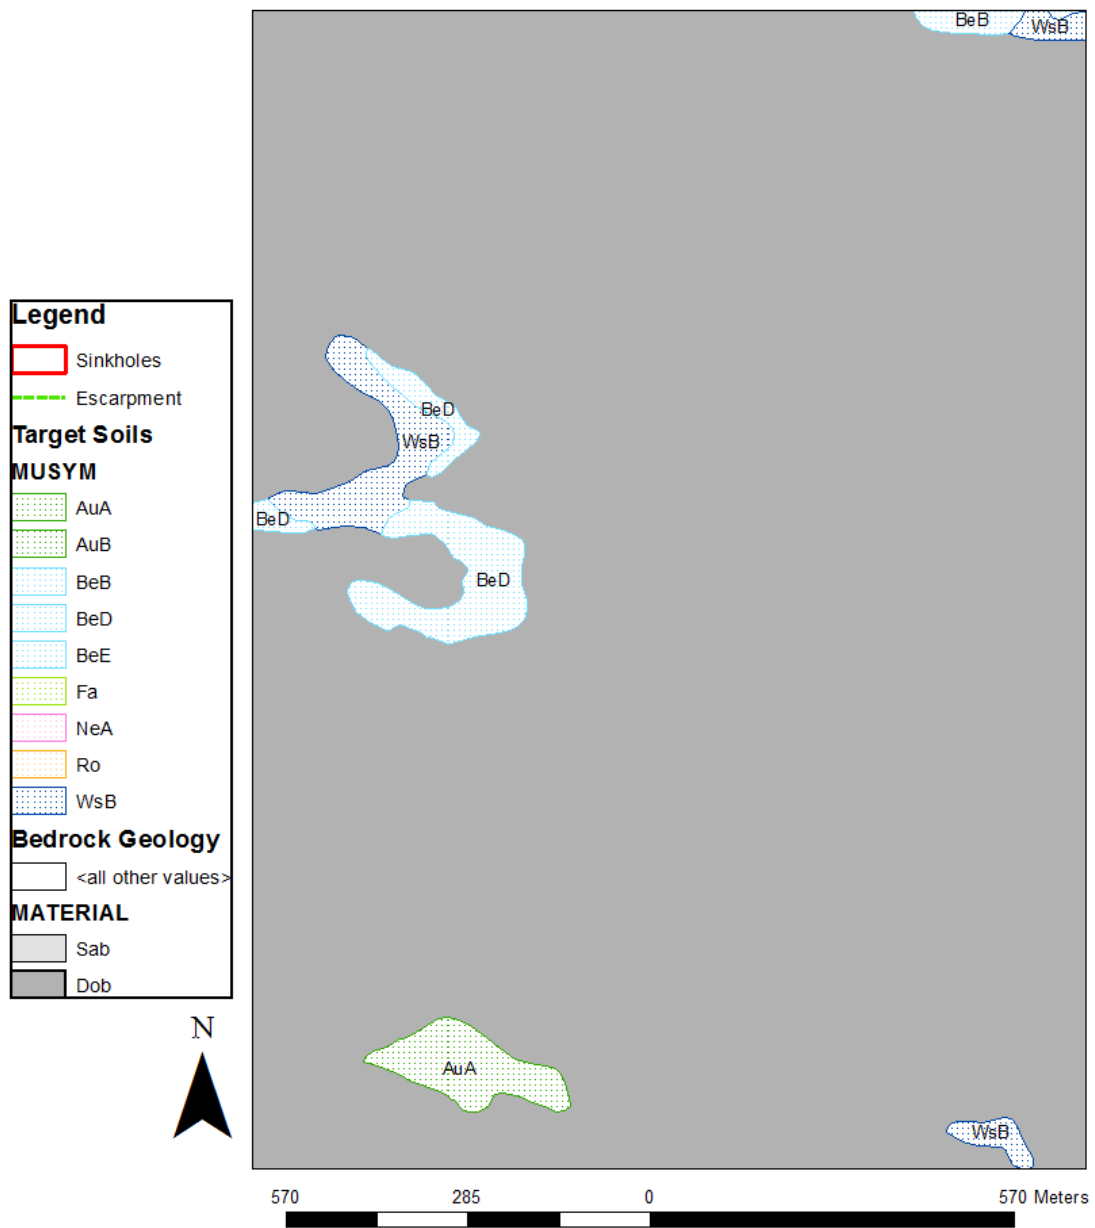
## County Building 2

Figure 16c. GIS-based map product for the County Building 2 false-positive site (unmarked, center of image). The feature is within the Onondaga Formation, squarely in karst terrain, with target soils nearby, both of the Benson and Wassiac series’.

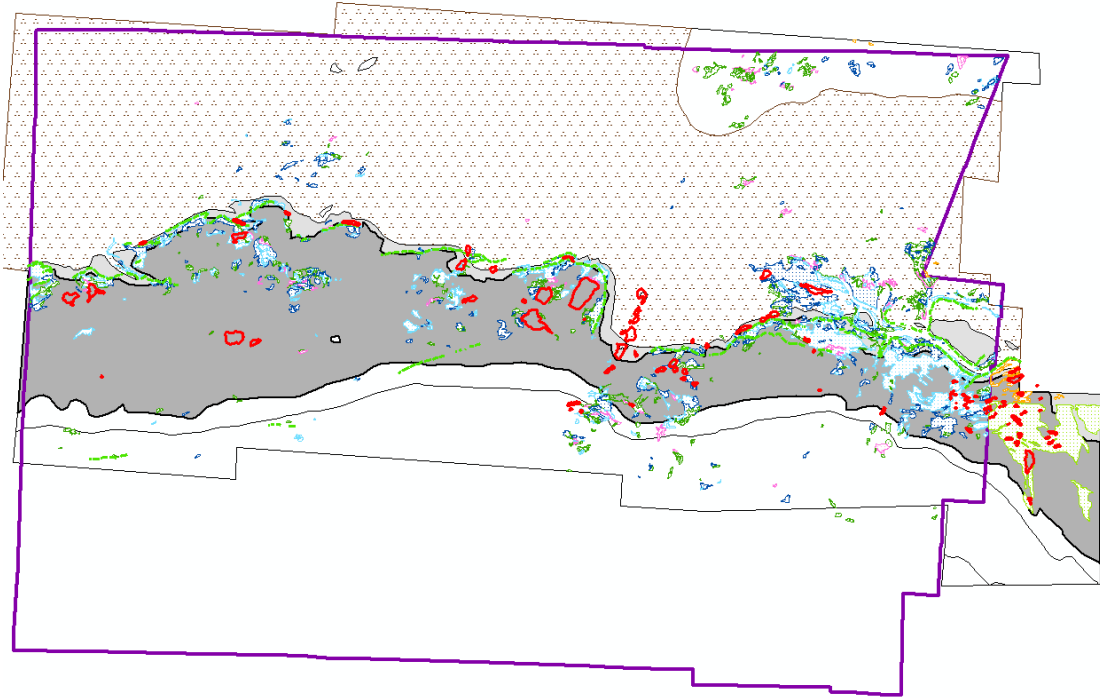
Map of Genesee County, NY, with extreme reached of southwestern Monroe County and northwestern Livingston County visible at right of image. Red polygons correspond to the 110 sinkholes in this study. Target Soils (various colored polygons), Bedrock (dark and light grey swaths that cross the county), and Bedrock Escarpments (green dashed lines) are also visible within the image.
